CENTRAL INTELLIGENCE AGENCY  
**INFORMATION REPORT**

REPORT NO.  SUBJECT Straightening of the Sulechow-Zielona Gora Highway/  
Comments on Facilities Available in CigacicePLACE ACQUIRED  
(BY SOURCE)

Sulechow-Zielona Gora Highway

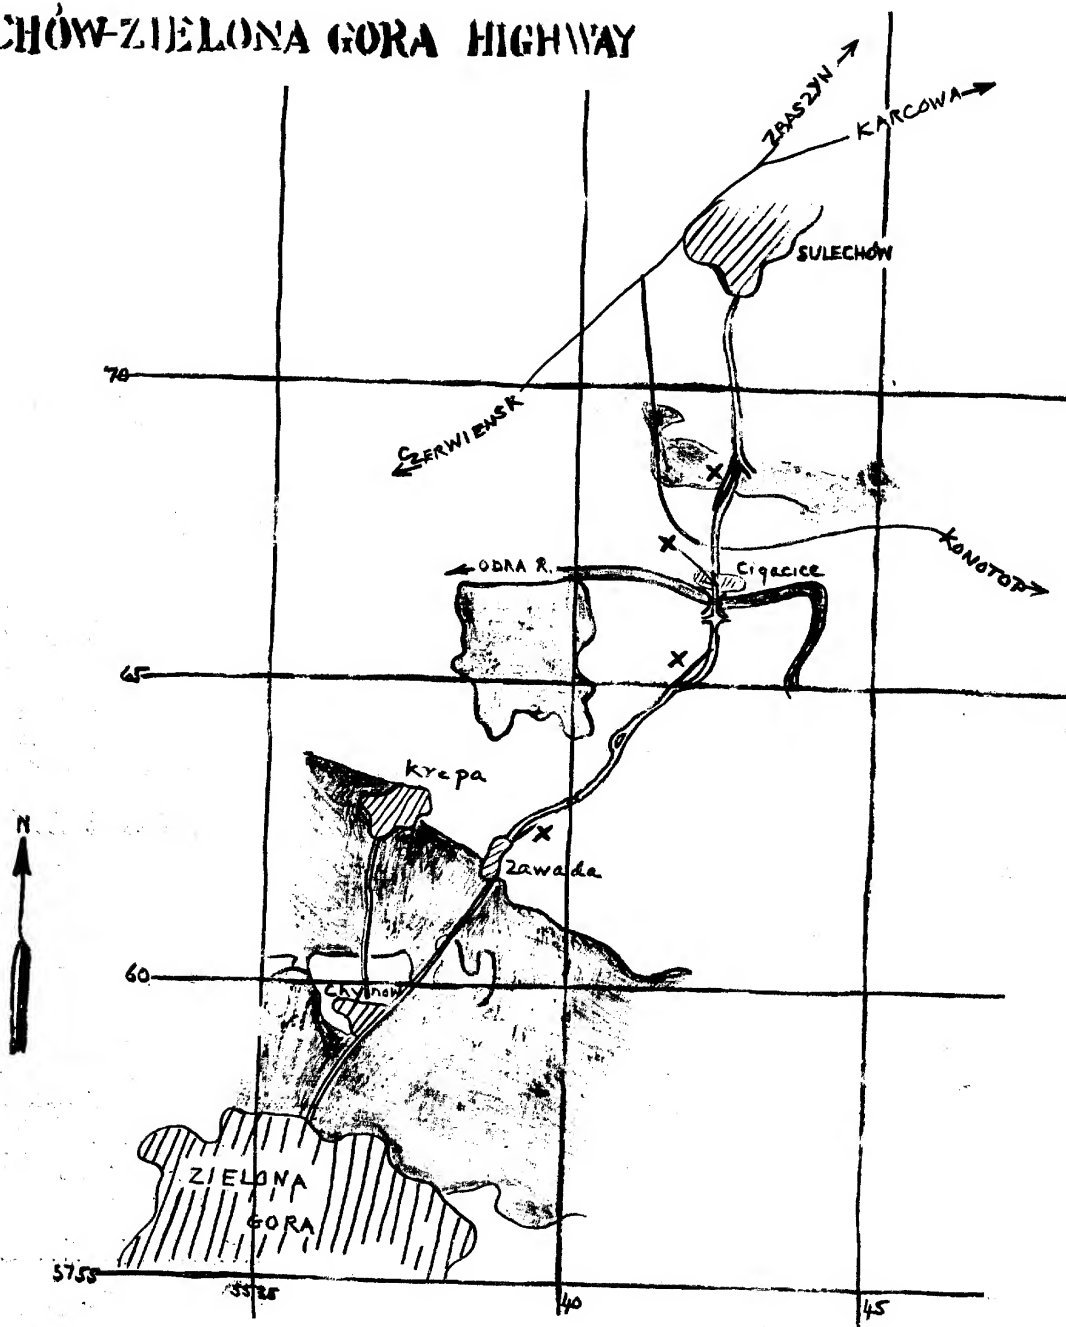
# SULECHÓW-ZIELONA GÓRA HIGHWAY

2. "The three sections of the highway which have been straightened are:

- (a) the section north of Cigacice (German: Odereck);
- (b) the section south of Cigacice, south of the Odra River;
- (c) a section south of (b), near the village of Zawada (German: Eichwaldau).

Legend: + = straightened-out highway segment.
